RAM 3500  
58520 ADAPTER KIT  
FOR 30035 KIT

## 2013-CURRENT RAM 3500 (REQUIRES 58520 BRACKET KIT)

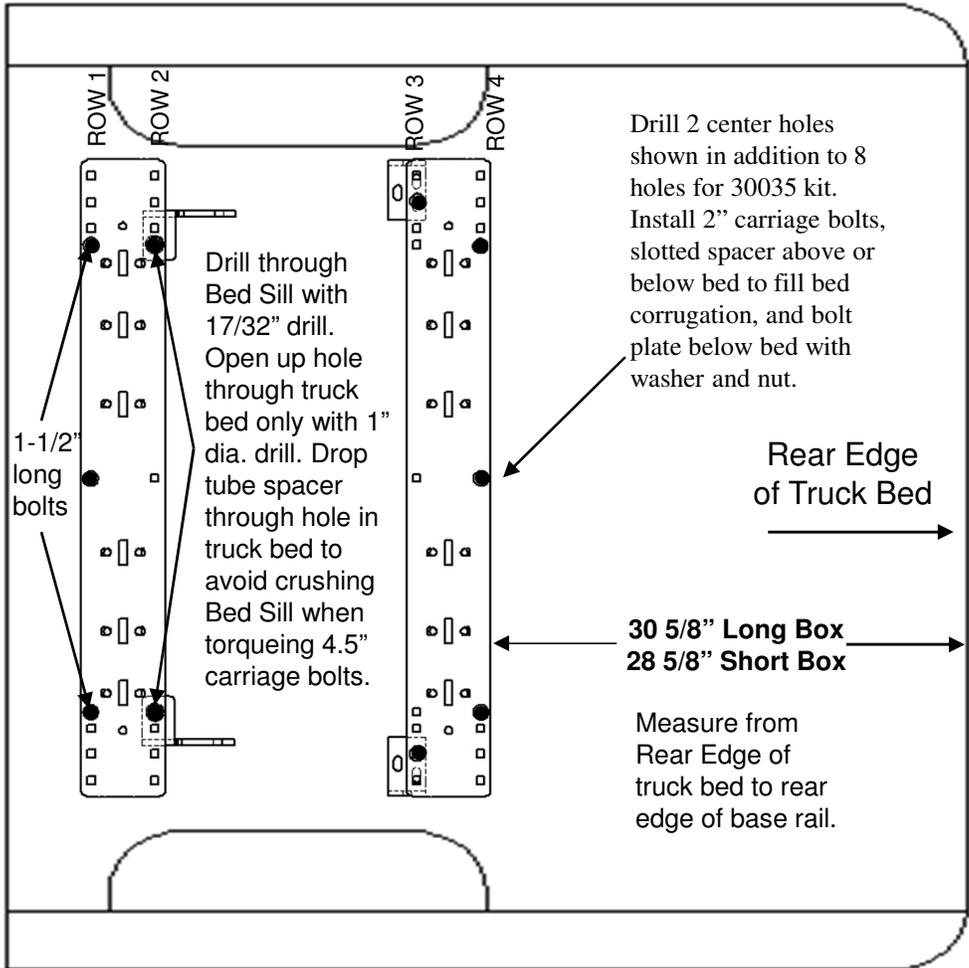
Front of Vehicle  
←

1. Tube spacers and 4.5" carriage bolts used to attach through forward Bed Sill (Row 2).
2. Rib neck bolts will need to be pulled through rearward access holes in frame with supplied pull wire.
3. Do not drill thru both walls of frame. Drill only thru wall of frame to which bracket is mounted.
4. It is very important that brackets in Row 3 are against the forward side of the Bed Sill as shown. **Due to dimensional instability in Bed Sill placement with the Ram truck**, interference could result when drilling in Row 2. Observe caution note below and double check all areas prior to drilling.
5. Forward brackets can be clamped to the frame using the 4-3/8" U-Bolts supplied. Torque to 75 Ft.-Lbs. (Grade 5).
6. \*Due to tubular frames having thinner walls than previous C channel frames, extra caution needs to be used when mounting with the optional welding.

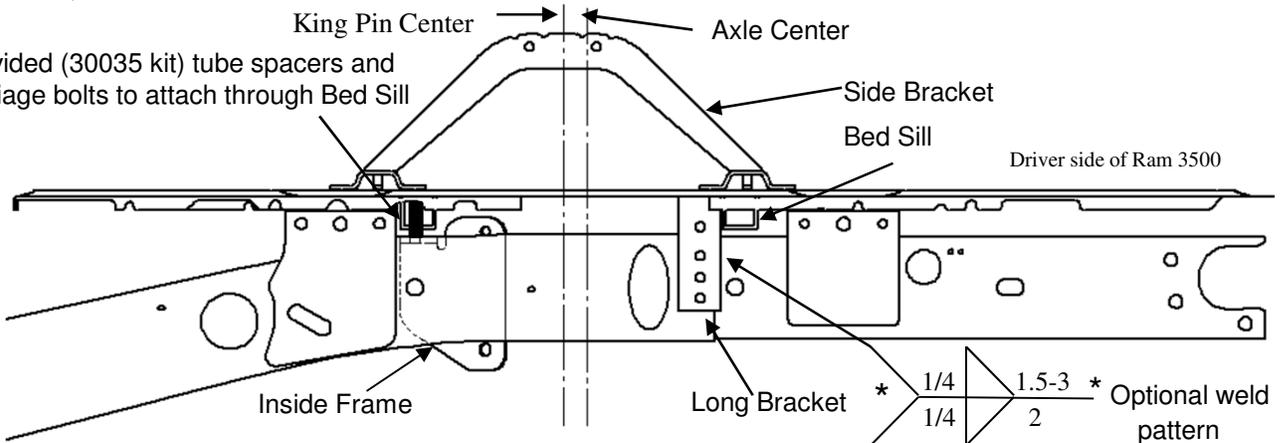
Use provided (30035 kit) tube spacers and 4.5" carriage bolts to attach through Bed Sill
